**Flood Control Project Maintenance
Levee Inspections**

Fall 2016 Levee Maintenance Deficiency Summary Report

**Flood Control Project Maintenance
Levee Inspections**
LMA District Cover Sheet
Fall 2016 Levee Inspection Results

Tehama County Flood Control and Water Conservation District

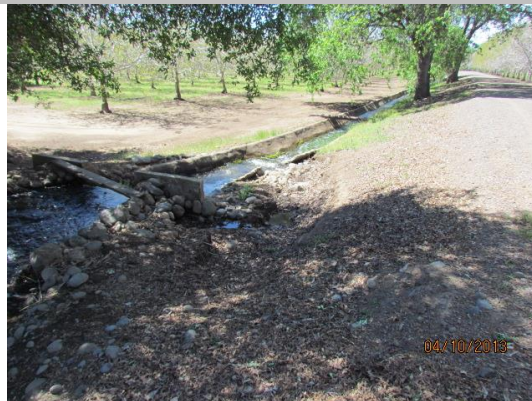
Photo 1 of 1 : FA_2016_NA0019_78_17_20160823_00004.jpg

View of the erosion along the landside slope.

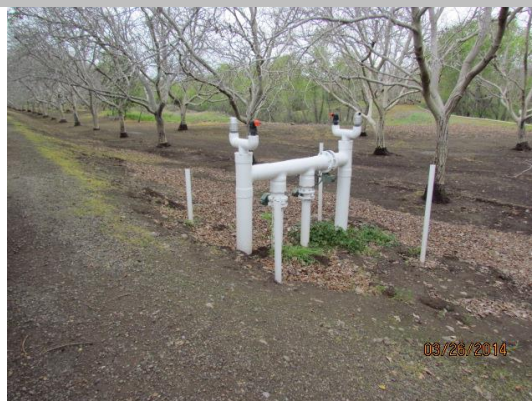
Photo 1 of 1 : FA_2016_NA0019_78_275_20160823_00013.jpg

LM Start	0.02	Rating **	U	Issue No.	275
LM End	0.02	Issue Type +	En	Location *	WS
Category	Earthen Levee			GPS Latitude/Longitude	
				Start	End
Item	Encroachments			39.973128 °	39.973128 °
				-121.980734 °	-121.980734 °
DWR ID	DWR_NA0019_01_s_2014_275				
Comment Code					
PI : Pipe					
Inspector Comment

View of the irrigation pipe along the waterside slope.

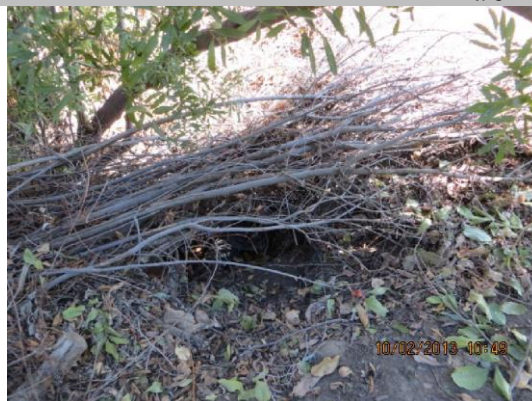
Photo 1 of 2 : UCIP_FA_2016_39840_39060.jpg

LM Start	0.17	Rating **	M	Issue No.	288
LM End	0.17	Issue Type +	En	Location *	WS
Category	Supplemental			GPS Latitude/Longitude	
				Start	End
Item	DWR UCIP Field Study			39.973302 °	39.973302 °
				-121.983538 °	-121.983538 °
DWR ID					
Comment Code					
Inspector Comment					
FS_ID:39840 DS_ID:24684 EP_NO: N/A Repair Type: Non-Urgent Crossing Status: Found UCIP Comments: No permit identified for this crossing. FIELD_STRUCT_DESC: 36-inch concrete irrigation pipe through the levee 0.5-feet below the crown. Concrete canal and distribution struture on LS shoulder. FS Date: 10/2/2013

Outlet covered by tree trimmings.

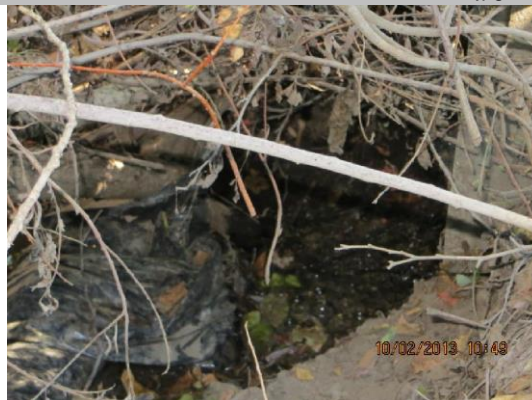
Photo 2 of 2 : UCIP_FA_2016_39840_39059.jpg

Pipe visible at WS outlet.

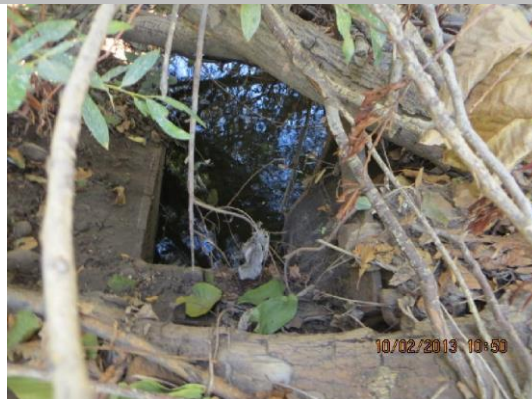
Photo 1 of 1 : UCIP_FA_2016_39838_39058.jpg

LM Start	0.17	Rating **	M	Issue No.	290
LM End	0.17	Issue Type +	En	Location *	WS
Category	Supplemental			GPS Latitude/Longitude	
				Start	End
Item	DWR UCIP Field Study			39.973285 °	39.973285 °
				-121.983531 °	-121.983531 °
DWR ID					
Comment Code					
Inspector Comment					
FS_ID:39838 DS_ID:24685 EP_NO: N/A Repair Type: Non-Urgent Crossing Status: Found UCIP Comments: No permit identified for this crossing. FIELD_STRUCT_DESC: 24-inch concrete irrigation pipe through the levee 2-feet below the crown. Concrete canal and distribution strutture on LS shoulder. Concrete U-shaped headwall and flapgate on WS toe. FS Date: 10/2/2013

Concrete U-shaped headwall and flapgate at WS toe.

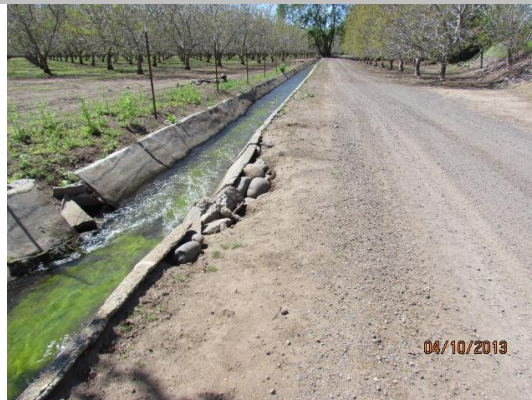
Photo 1 of 1 : FA_2016_NA0019_78_18_20160823_00005.jpg

LM Start	0.41	Rating **	M	Issue No.	18
LM End	0.41	Issue Type +	Ma	Location *	LS
Category	Earthen Levee			GPS Latitude/Longitude	
				Start	End
Item	Erosion / Bank Caving			39.972560 °	39.972560 °
				-121.987759 °	-121.987759 °
DWR ID	DWR_NA0019_01_s_2013_18				
Comment Code					
E1 : Note and monitor erosion site.					
Inspector Comment

View of the erosion along the landside slope.

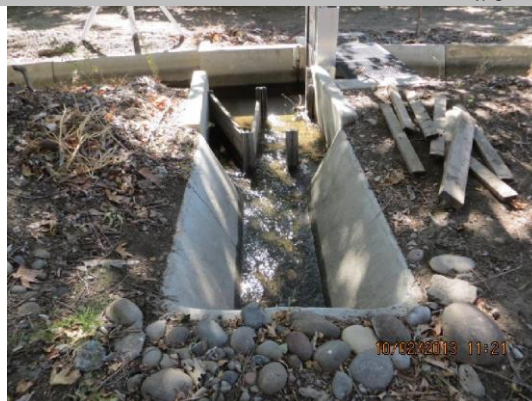
Photo 1 of 2 : UCIP_FA_2016_39839_39063.jpg

FS_ID:39839
DS_ID:24686
EP_NO: N/A
Repair Type: Non-Urgent
Crossing Status: Found
UCIP Comments: No permit identified for crossing.
FIELD_STRUCT_DESC: 20-inch concrete irrigation pipe through the levee 2-feet below the crown. Concrete canal and distribution structure with slat boards on LS shoulder.
FS Date: 10/2/2013

Concrete canal/distribution box on LS shoulder.

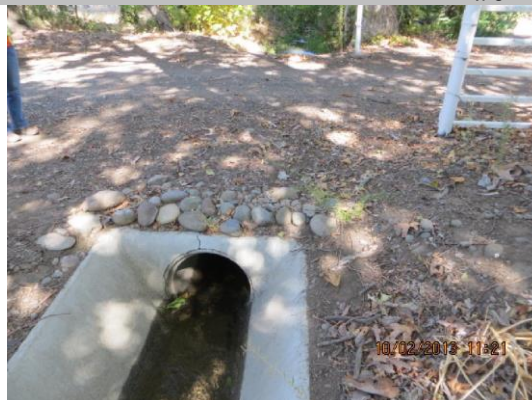
Photo 2 of 2 : UCIP_FA_2016_39839_39062.jpg

Concrete headwall at canal on LS shoulder.

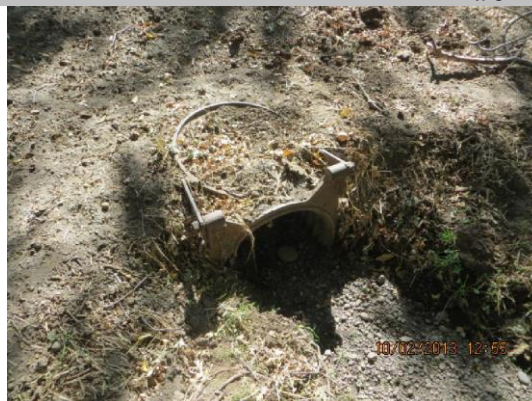
Photo 1 of 2 : UCIP_FA_2016_21729_36922.jpg

LM Start	1.67	Rating **	U	Issue No.	278
LM End	1.67	Issue Type +	En	Location *	WS
Category	Supplemental			GPS Latitude/Longitude	
				Start	End
Item	DWR UCIP Field Study			39.968642 °	39.968642 °
				-122.010494 °	-122.010494 °
DWR ID					
Comment Code					
Inspector Comment					
FS_ID:21729					
DS_ID:20770					
EP_NO: N/A					
Repair Type: Urgent					
Crossing Status: Found					
UCIP Comments: Flapgate blocked by soil buildup.					
FIELD_STRUCT_DESC: 24-inch pipe through the levee 1.5-feet below the crown. Flap gate on the WS toe. Originally included in O+M manual (1957). As-built drawings available 50-4-2394.					
FS Date: 10/2/2013

Flapgate on WS toe.

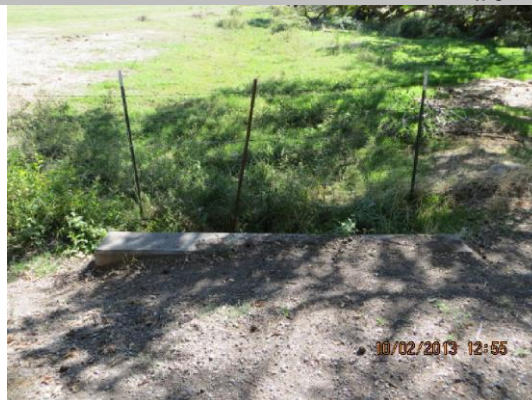
Photo 2 of 2 : UCIP_FA_2016_21729_36921.jpg

Concrete headwall on LS toe.

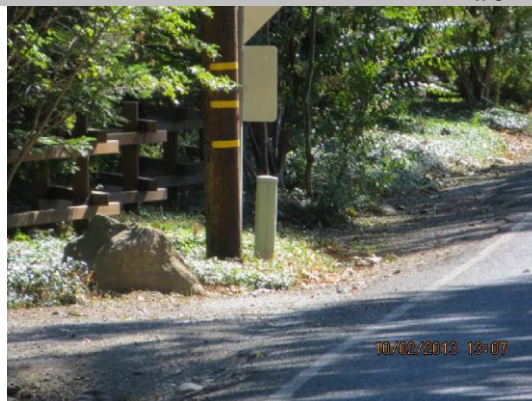
Photo 1 of 2 : UCIP_FA_2016_39837_39067.jpg

LM Start	1.88	Rating **	M	Issue No.	289
LM End	1.88	Issue Type +	En	Location *	LS
Category	Supplemental			GPS Latitude/Longitude	
				Start	End
Item	DWR UCIP Field Study			39.969156 °	39.969156 °
				-122.013809 °	-122.013809 °
DWR ID					
Comment Code					
Inspector Comment					
FS_ID:39837					
DS_ID:24690					
EP_NO: N/A					
Repair Type: Non-Urgent					
Crossing Status: Found					
UCIP Comments: No permit identified for this crossing.					
FIELD_STRUCT_DESC: 4-inch steel conduit through the levee at an unknown depth. Junction box off LS toe next to JP and roadway.					
Conduit visible on upstream side of bridge at Deer Creek crossing.					
FS Date: 10/2/2013

Communication box off LS shoulder next to roadway.

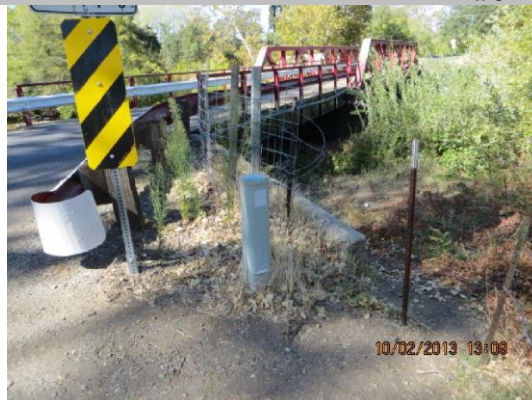
Photo 2 of 2 : UCIP_FA_2016_39837_39066.jpg

Communication box on WS shoulder.

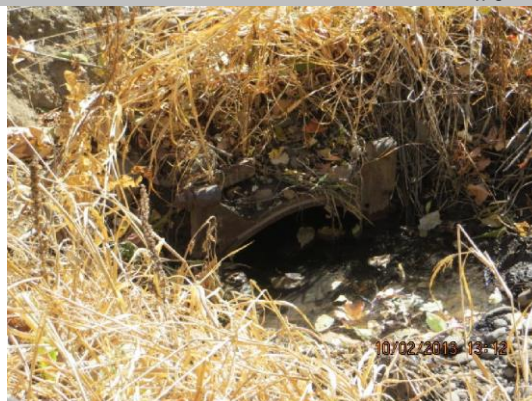
Photo 1 of 2 : UCIP_FA_2016_21730_36925.jpg

LM Start	1.89	Rating **	U	Issue No.	279
LM End	1.89	Issue Type +	En	Location *	LS
Category	Supplemental			GPS Latitude/Longitude	
				Start	End
Item	DWR UCIP Field Study			39.969105 °	39.969105 °
				-122.014028 °	-122.014028 °
DWR ID					
Comment Code					
Inspector Comment					
FS_ID:21730					
DS_ID:20769					
EP_NO: N/A					
Repair Type: Urgent					
Crossing Status: Found					
UCIP Comments: Flapgate missing or buried on WS toe. Pipe partially blocked by soil on WS toe.					
FIELD_STRUCT_DESC: 24-inch corrugated metal pipe through the levee, 7-feet below the crown. Flap gate on the waterward end. 5'X5' concrete control structure on LS toe. Originally included in O+M manual (1957). As-built drawings available 50-4-2394.					
FS Date: 10/2/2013

Pipe on WS toe with flapgate hinges.

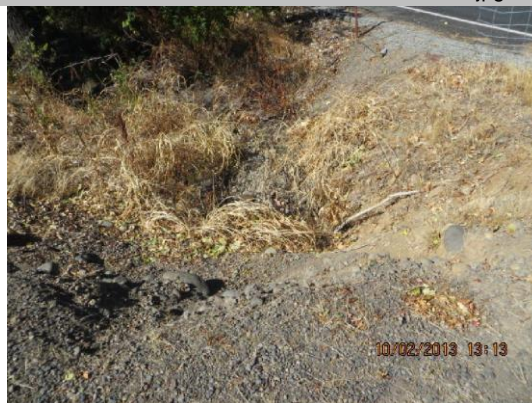
Photo 2 of 2 : UCIP_FA_2016_21730_36924.jpg

Outlet on WS toe.

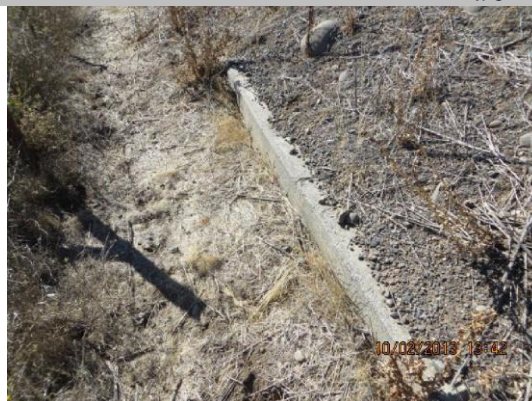
Photo 1 of 1 : UCIP_FA_2016_22823_38941.jpg

LM Start	2.57	Rating **	M	Issue No.	281
LM End	2.57	Issue Type +	En	Location *	LS
Category	Supplemental			GPS Latitude/Longitude	
				Start	End
Item	DWR UCIP Field Study			39.966363 °	39.966363 °
				-122.025755 °	-122.025755 °
DWR ID					
Comment Code					
Inspector Comment					
FS_ID:22823					
DS_ID:20877					
EP_NO: N/A					
Repair Type: Non-Urgent					
Crossing Status: Found					
UCIP Comments: Headwall covered with soil. Needs to be cleared at both ends.					
FIELD_STRUCT_DESC: 24-inch Corrugated mtl pipe through the levee 5-feet below the crown. Calco automatic drainage gate.					
Originally included in O+M manual (1957). As-built drawings available 50-4-2394.					
FS Date: 10/2/2013

Concrete headwall on LS toe.

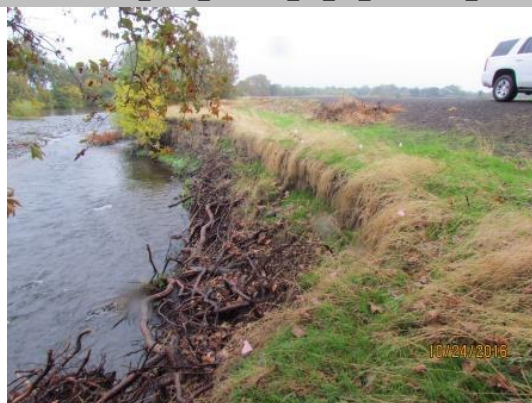
Photo 1 of 1 : FA_2016_NA0019_78_39_20161107_00056.jpg

LM Start	2.78	Rating **	M	Issue No.	39
LM End	2.78	Issue Type +	Ma	Location *	WS
Category	Earthen Levee			GPS Latitude/Longitude	
				Start	End
Item	Erosion / Bank Caving			39.964772 °	39.964772 °
				-122.029023 °	-122.029023 °
DWR ID	DWR_NA0019_01_s_2015_39				
Comment Code					
E1 : Note and monitor erosion site.					
Inspector Comment					
Monitor the erosion during high water.

View of the erosion along the waterside toe.

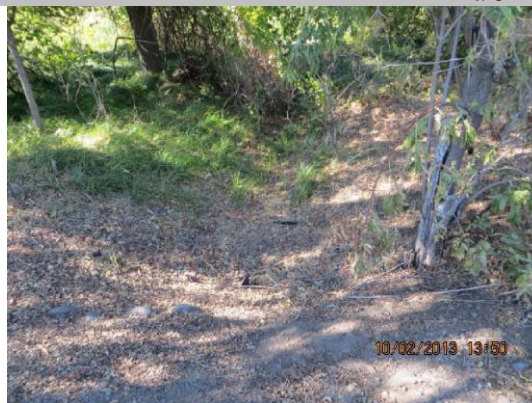
Photo 1 of 2 : UCIP_FA_2016_22824_38946.jpg

LM Start	2.86	Rating **	M	Issue No.	282
LM End	2.86	Issue Type +	En	Location *	CR
Category	Supplemental			GPS Latitude/Longitude	
				Start	End
Item	DWR UCIP Field Study			39.963938 °	39.963938 °
				-122.030128 °	-122.030128 °
DWR ID					
Comment Code					
Inspector Comment					
FS_ID:22824 DS_ID:20767 EP_NO: N/A Repair Type: Non-Urgent Crossing Status: Found UCIP Comments: Pipe blocked by soil. FIELD_STRUCT_DESC: 24-inch pipe through the levee 6-feet below the crown. Flap gate on the waterward end. Originally included in O+M manual (1957). As-built drawings available 50-4-2394. FS Date: 10/2/2013

Flapgate blocked by soil and debris.

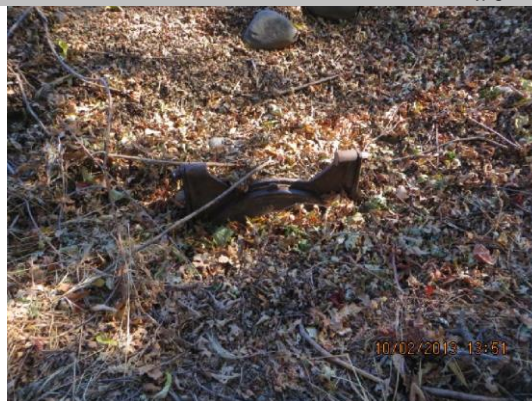
Photo 2 of 2 : UCIP_FA_2016_22824_38945.jpg

LM Start	2.86	Rating **	M	Issue No.	282 (cont)
LM End	2.86	Issue Type +	En	Location *	CR
Category	Supplemental			GPS Latitude/Longitude	
				Start	End
Item	DWR UCIP Field Study			39.963938 °	39.963938 °
				-122.030128 °	-122.030128 °
DWR ID					
Comment Code					
Inspector Comment					
FS_ID:22824 DS_ID:20767 EP_NO: N/A Repair Type: Non-Urgent Crossing Status: Found UCIP Comments: Pipe blocked by soil. FIELD_STRUCT_DESC: 24-inch pipe through the levee 6-feet below the crown. Flap gate on the waterward end. Originally included in O+M manual (1957). As-built drawings available 50-4-2394. FS Date: 10/2/2013

Flapgate blocked by soil and debris.

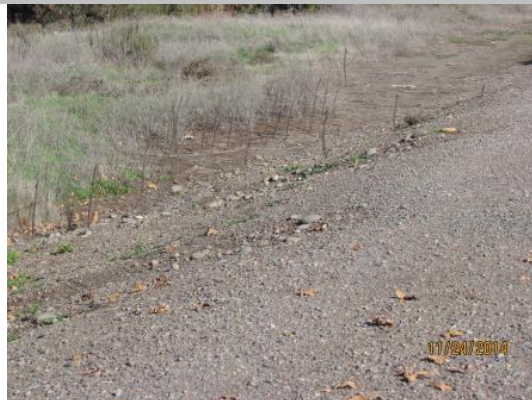
Photo 1 of 1 : FA_2016_NA0019_78_38_20160823_00010.jpg

LM Start	2.86	Rating **	M	Issue No.	38
LM End	2.86	Issue Type +	Ma	Location *	LS
Category	Earthen Levee			GPS Latitude/Longitude	
				Start	End
Item	Slope Stability			39.963928 °	39.963928 °
				-122.030120 °	-122.030120 °
DWR ID	DWR_NA0019_01_f_2014_38				
Comment Code					
S1 : Repair slope instability.					
Inspector Comment

View of erosion from the cattle on both slopes.

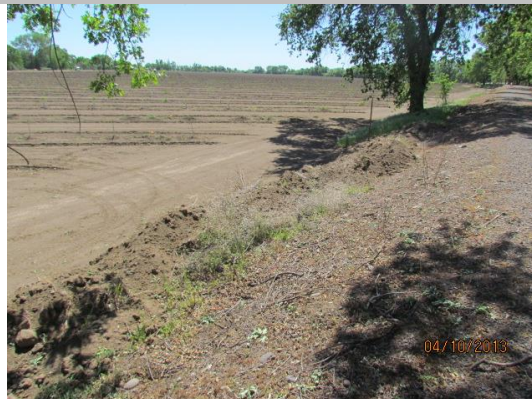
Photo 1 of 1 : FA_2016_NA0019_78_20_20160823_00007.jpg

LM Start	2.88	Rating **	M	Issue No.	20
LM End	2.88	Issue Type +	Ma	Location *	LS
Category	Earthen Levee			GPS Latitude/Longitude	
				Start	End
Item	Slope Stability			39.963709 °	39.963709 °
				-122.030384 °	-122.030384 °
DWR ID	DWR_NA0019_01_s_2013_20				
Comment Code					
S1 : Repair slope instability.					
Inspector Comment

View of the erosion along the landside slope.

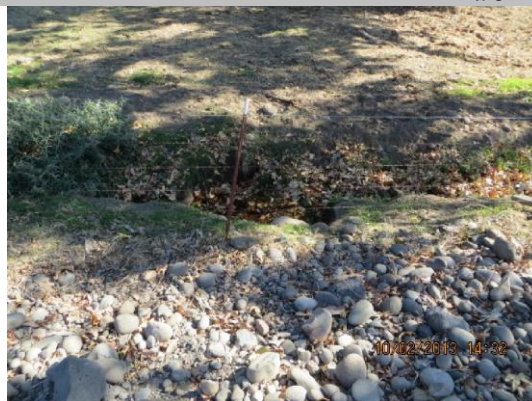
Photo 1 of 2 : UCIP_FA_2016_22825_38952.jpg

LM Start	3.29	Rating **	M	Issue No.	283
LM End	3.29	Issue Type +	En	Location *	LS
Category	Supplemental			GPS Latitude/Longitude	
				Start	End
Item	DWR UCIP Field Study			39.947484 °	39.947484 °
				-122.049011 °	-122.049011 °
DWR ID					
Comment Code					
Inspector Comment					
FS_ID:22825 DS_ID:20766 EP_NO: N/A Repair Type: Non-Urgent Crossing Status: Indicator Found UCIP Comments: Pipe buried. Water flows to low spot and dissappears, but pipe not visible. FIELD_STRUCT_DESC: 24-inch pipe through the levee 8-feet below the crown, flap gate on waterward end. Originally included in O+M manual (1957). As-built drawing No. 50-4-2394. FS Date: 10/2/2013

Low spot with water on LS toe.

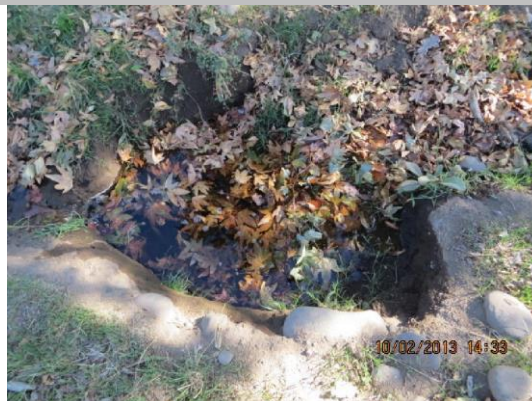
Photo 2 of 2 : UCIP_FA_2016_22825_38951.jpg

Low spot with water on LS toe.

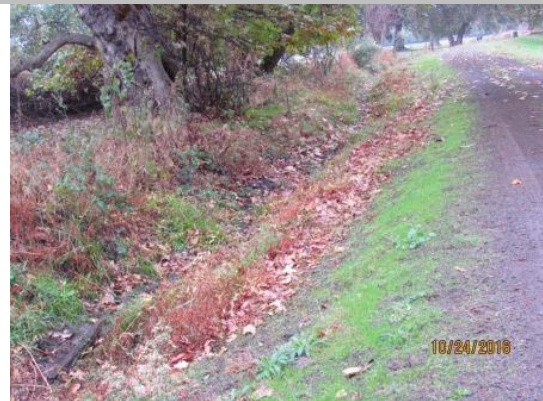
Photo 1 of 1 : FA_2016_NA0019_78_35_20161107_00057.jpg

View of the vegetation along the landside slope and toe.

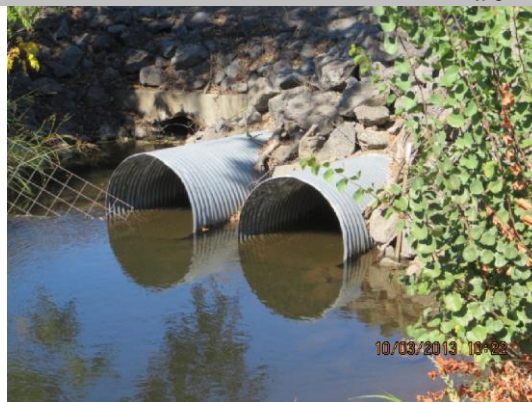
Photo 2 of 2 : UCIP_FA_2016_23007_39069.jpg

FS_ID:23007
DS_ID:24687
EP_NO: N/A
Repair Type: Non-Urgent
Crossing Status: Found
UCIP Comments: No permit identified for this crossing.
FIELD_STRUCT_DESC: 48-inch corrugated metal drainpipe through the levee, 6-feet below the crown. Flap gate on the waterward end.
FS Date: 10/3/2013

Pipe visible on LS toe.

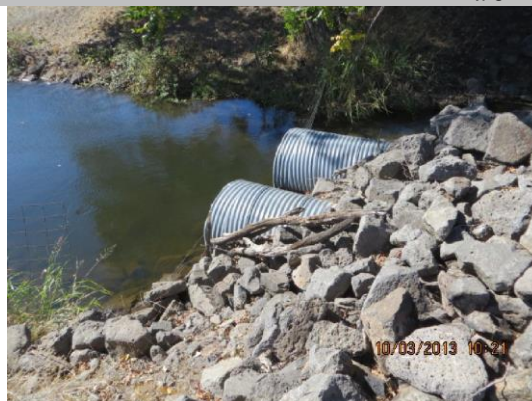
Photo 1 of 2 : UCIP_FA_2016_39836_39073.jpg

LM Start	3.60	Rating **	M	Issue No.	292
LM End	3.60	Issue Type +	En	Location *	LS
Category	Supplemental			GPS Latitude/Longitude	
				Start	End
Item	DWR UCIP Field Study			39.945952 °	39.945952 °
				-122.054259 °	-122.054259 °
DWR ID					
Comment Code					
Inspector Comment					
FS_ID:39836 DS_ID:24688 EP_NO: N/A Repair Type: Non-Urgent Crossing Status: Found UCIP Comments: No permit identified for this crossing. Brush should be removed from flapgate outlet. FIELD_STRUCT_DESC: 48-inch corrugated metal drainpipe through the levee, 6-feet below the crown. Flap gate on the waterward end. FS Date: 10/3/2013

Pipe visible on LS toe.

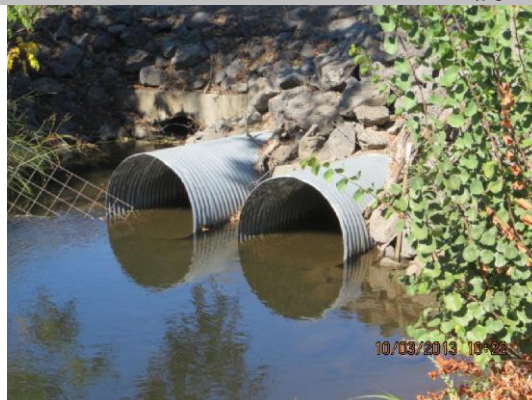
Photo 2 of 2 : UCIP_FA_2016_39836_39072.jpg

Pipe visible on LS toe.

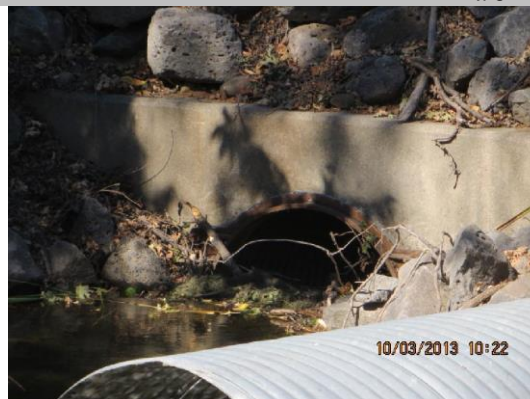
Photo 1 of 2 : UCIP_FA_2016_41126_39076.jpg

LM Start	3.60	Rating **	U	Issue No.	287
LM End	3.60	Issue Type +	En	Location *	LS
Category	Supplemental			GPS Latitude/Longitude	
				Start	End
Item	DWR UCIP Field Study			39.945928 °	39.945928 °
				-122.054305 °	-122.054305 °
DWR ID					
Comment Code					
Inspector Comment					
FS_ID:41126					
DS_ID:24689					
EP_NO: N/A					
Repair Type: Urgent					
Crossing Status: Found					
UCIP Comments: Flapgate does not fully close. Needs brush cleared away from outlet.					
FIELD_STRUCT_DESC: 36-inch corrugated metal drainpipe through the levee, 7-feet below the crown. Flap gate on the waterward end.					
Concrete headwall on LS toe.					
FS Date: 10/3/2013

Pipe visible at headwall on LS toe.

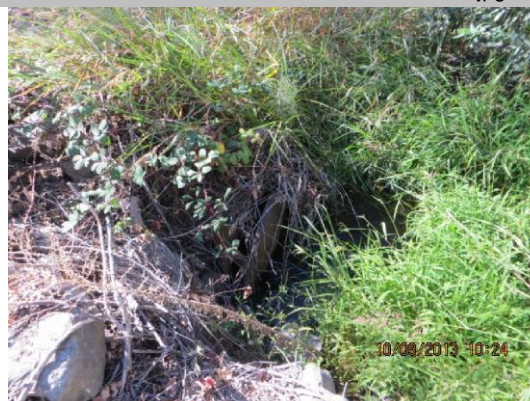
Photo 2 of 2 : UCIP_FA_2016_41126_39075.jpg

Flapgate visible on WS toe.

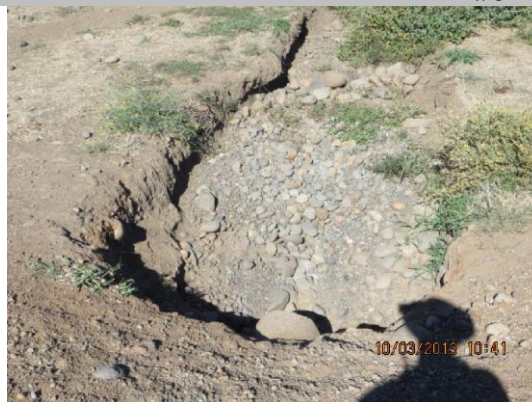
Photo 2 of 2 : UCIP_FA_2016_23094_39306.jpg

FS_ID:23094
DS_ID:20763
EP_NO: N/A
Repair Type: Non-Urgent
Crossing Status: Found
UCIP Comments: Erosion on WS toe.
FIELD_STRUCT_DESC: 12-inch concrete stormdrain pipe, through the levee, 2-feet below the crown.
FS Date: 10/3/2013

Concrete pipe at outlet on WS toe.

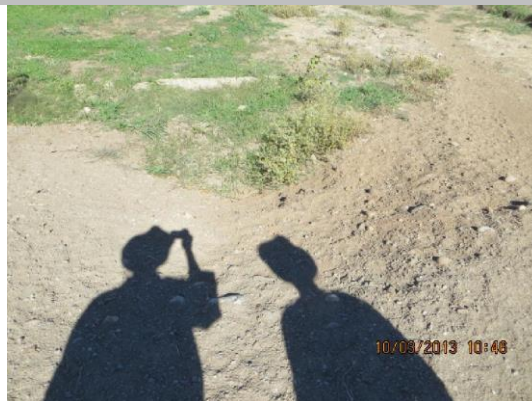
Photo 2 of 2 : UCIP_FA_2016_23092_39297.jpg

Pipe outlet on WS toe.

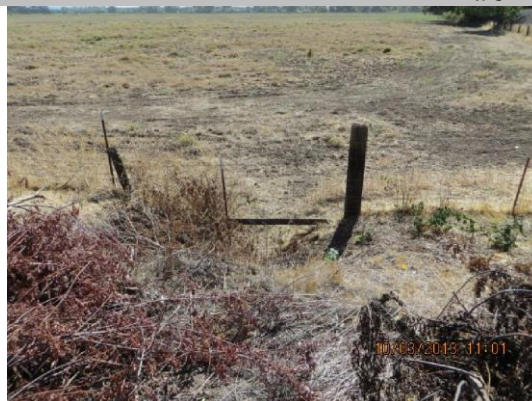
Photo 1 of 2 : UCIP_FA_2016_21743_36942.jpg

Inlet on LS toe.

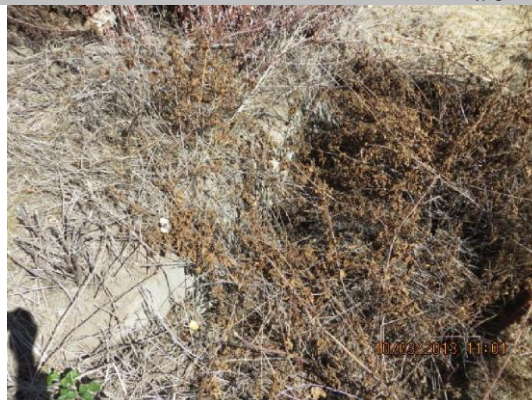
Photo 2 of 2 : UCIP_FA_2016_21743_36941.jpg

Concrete headwall at inlet on LS toe.

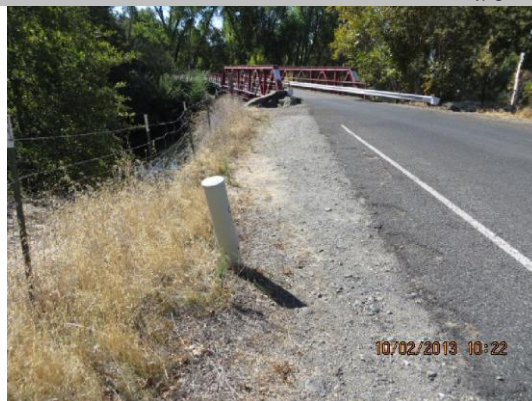
Photo 1 of 2 : UCIP_FA_2016_40789_39057.jpg

Communication line access box on WS shoulder.

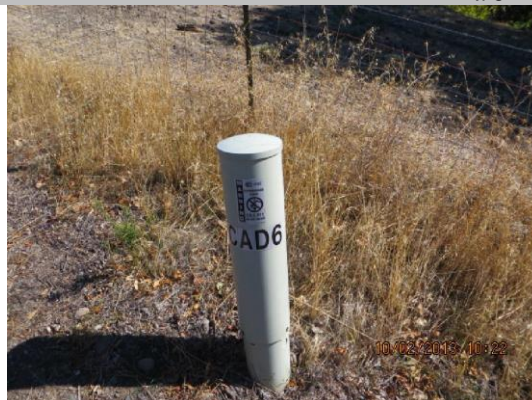
Photo 2 of 2 : UCIP_FA_2016_40789_39056.jpg

Communication line access box on WS shoulder.

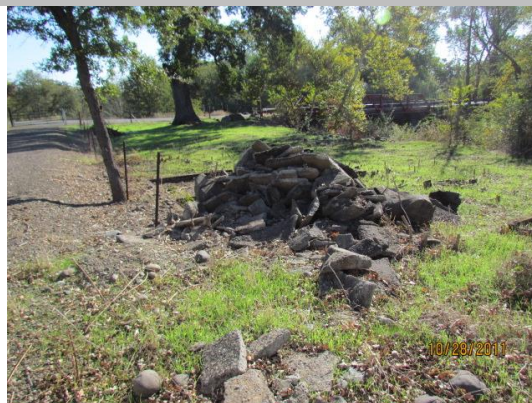
Photo 1 of 1 : FA_2016_NA0019_79_4_20160823_00003.jpg

View of the concrete pile along the waterside toe.

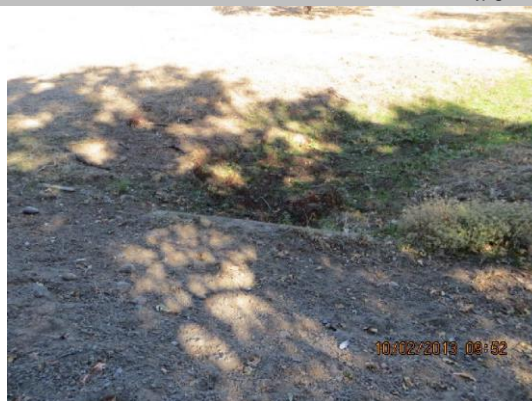
Photo 1 of 2 : UCIP_FA_2016_41123_36902.jpg

Concrete headwall at LS toe.

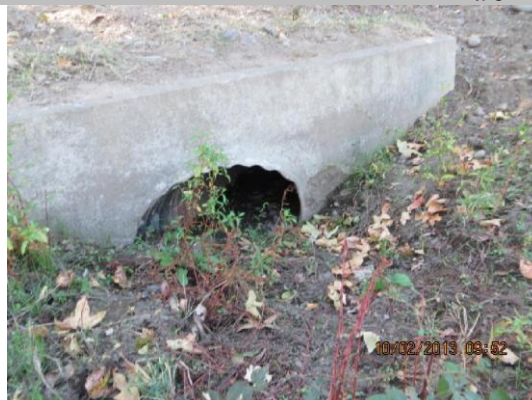
Photo 2 of 2 : UCIP_FA_2016_41123_36901.jpg

Concrete headwall at LS toe.

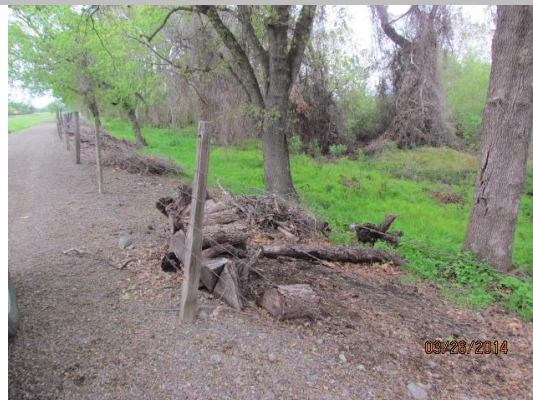
Photo 1 of 1 : FA_2016_NA0019_79_6_20160823_00004.jpg

View of the firewood along the waterside slope.

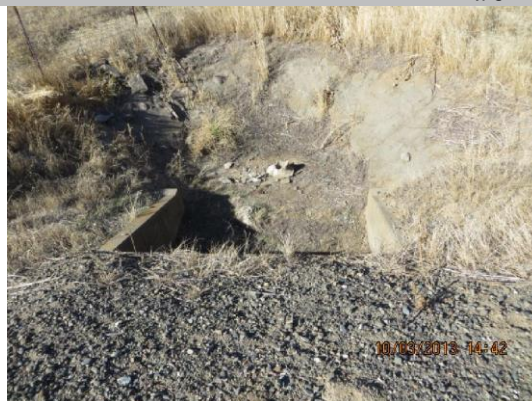
Photo 1 of 2 : UCIP_FA_2016_41125_37061.jpg

Concrete U-shaped headwall on LS toe.

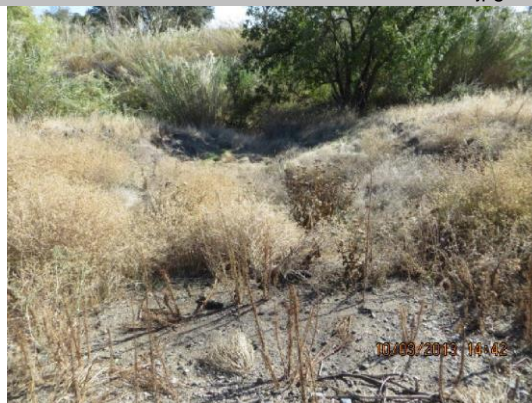
Photo 2 of 2 : UCIP_FA_2016_41125_37060.jpg

Concrete U-shaped headwall on WS toe.

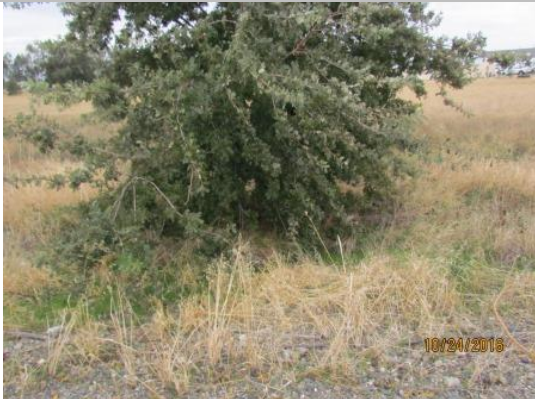
Photo 1 of 1 : FA_2016_NA0019_81_13_20161107_00026.jpg

View of a tree with overhanging branches.

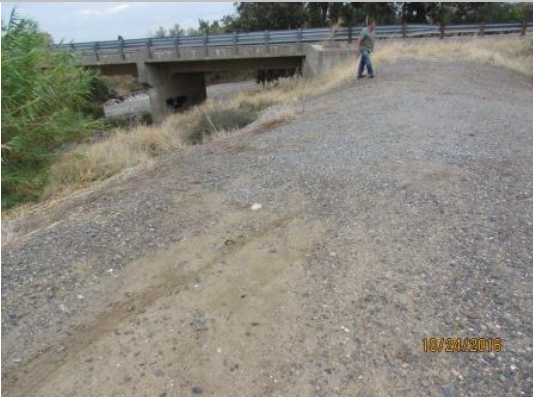
Photo 1 of 1 : FA_2016_NA00019_81_27_20161107_00028.jpg

View of the slope instability caused by vehicles.

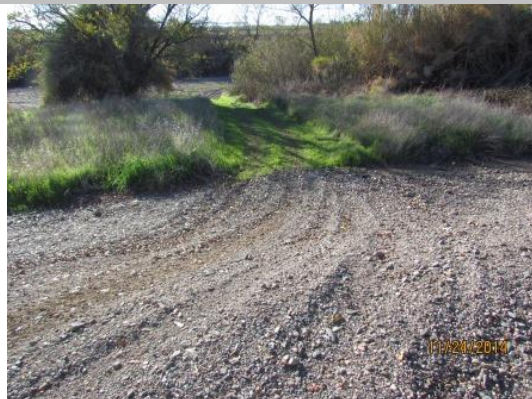
Photo 1 of 1 : FA_2016_NA0019_81_16_20160823_00010.jpg

View of the slope instability caused by vehicles along the waterside slope.

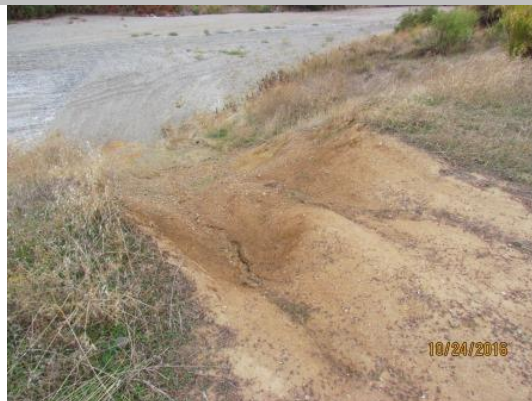
Photo 1 of 1 : FA_2016_NA0019_81_29_20161107_00029.jpg

View of the slope instability caused by vehicles along the waterside slope.

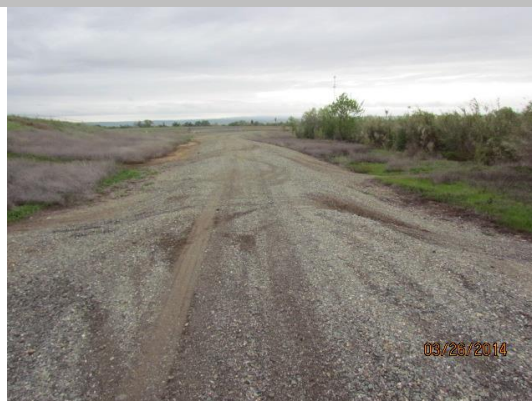
Photo 1 of 2 : FA_2016_NA0019_81_3_20160823_00003.jpg

View of the levee slope damaged by vehicle traffic.

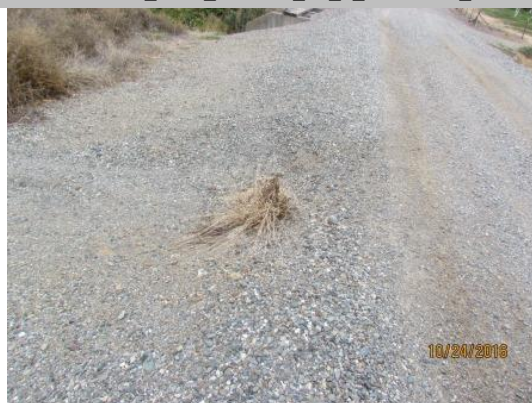
Photo 2 of 2 : FA_2016_NA0019_81_3_20161107_00030.jpg

View of a dip along the levee slope.

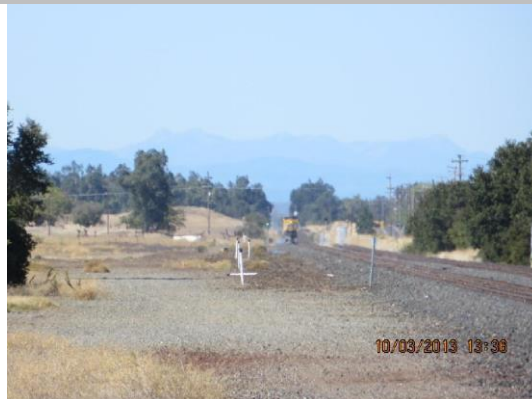
Photo 1 of 1 : UCIP_FA_2016_23051_39135.jpg

Fiber optic line markers off LS shoulder.

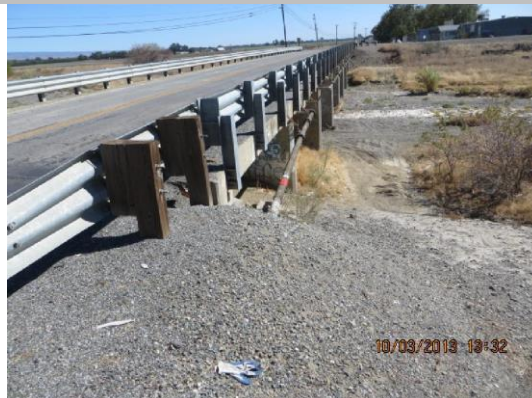
Photo 1 of 2 : UCIP_FA_2016_23045_39106.jpg

Gasline on upstream side of bridge.

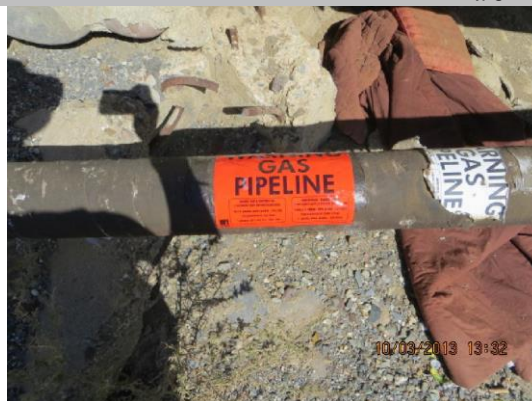
Photo 2 of 2 : UCIP_FA_2016_23045_39105.jpg

Gasline on upstream side of bridge.

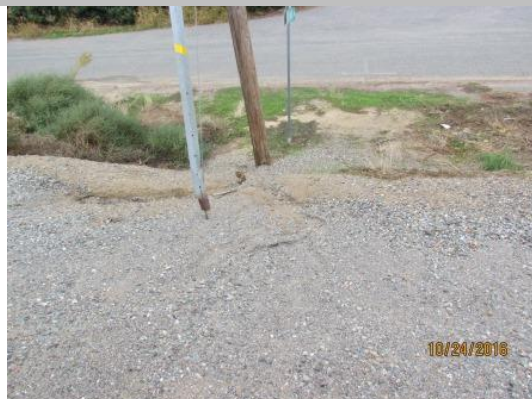
Photo 1 of 1 : FA_2016_NA0019_81_32_20161107_00034.jpg

View of the slope instability caused by vehicles along the landside slope.

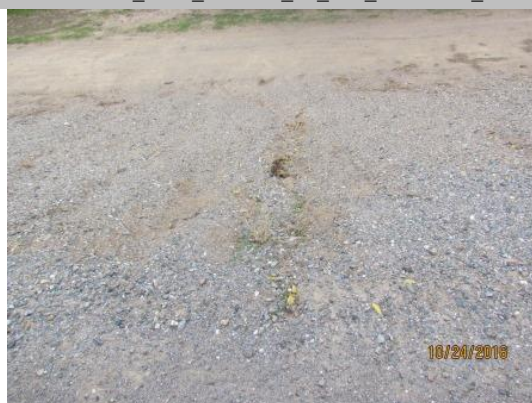
Photo 1 of 1 : FA_2016_NA0019_81_916_20161107_00035.jpg

View of the slope instability caused by vehicles along the landside slope.

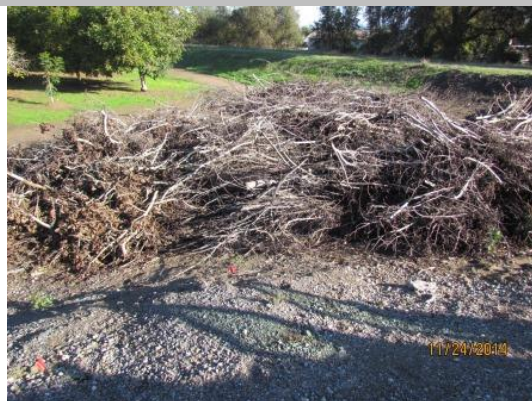
Photo 1 of 1 : FA_2016_NA0019_81_17_20160823_00011.jpg

View of the prunings along the landside slope.

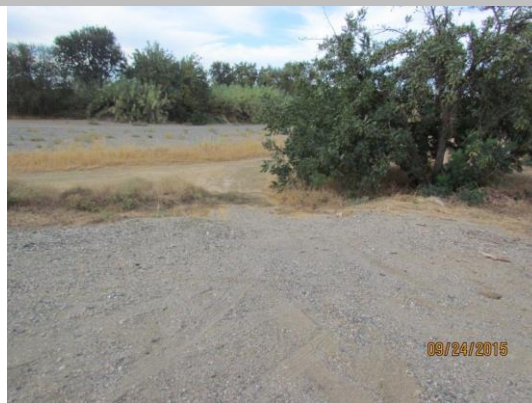
Photo 1 of 1 : FA_2016_NA0019_81_10_20160823_00005.jpg

View of the slope instability caused by vehicles along the landside slope.

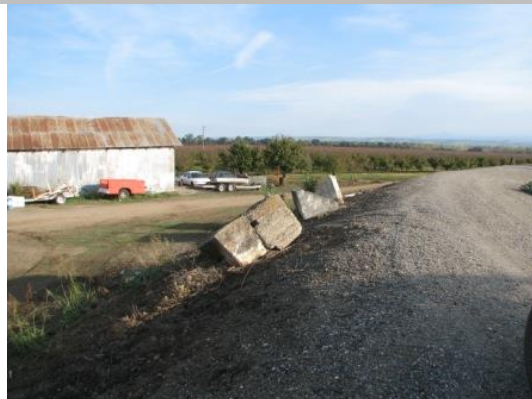
Photo 1 of 1 : FA_2016_NA0019_81_1_20160823_00001.jpg

View of the concrete stairways on the slope.

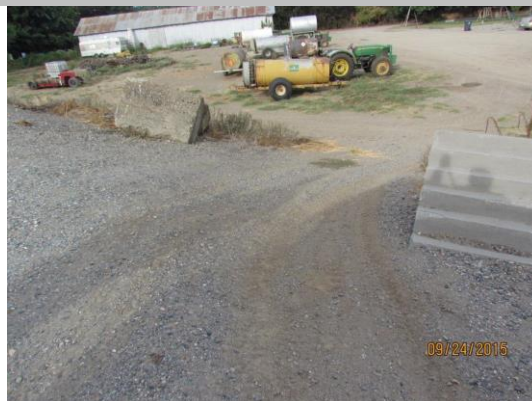
Photo 1 of 1 : FA_2016_NA0019_81_25_20160823_00019.jpg

View of the slope instability caused by vehicles along the landside slope.

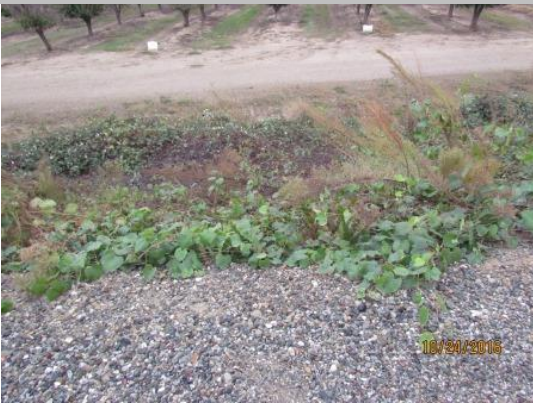
Photo 1 of 1 : FA_2016_NA0019_81_39_20161107_00037.jpg

View of the blackberries along the landside slope blocking visibility and access.

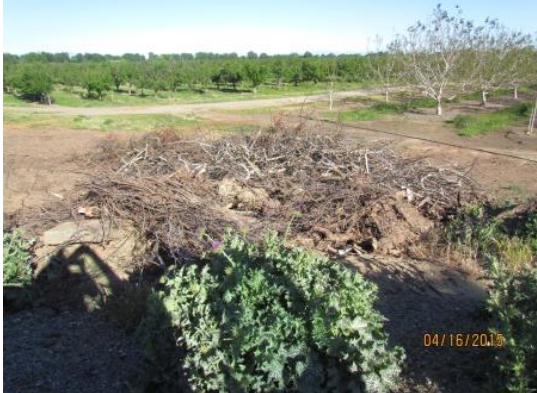
Photo 1 of 1 : FA_2016_NA0019_81_21_20160823_00015.jpg

View of the prunings along landside toe.

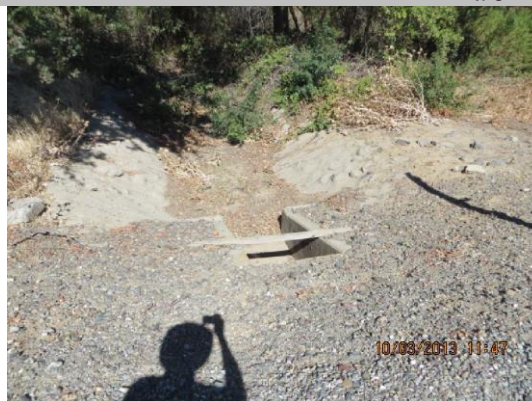
Photo 1 of 2 : UCIP_FA_2016_41124_36953.jpg

Concrete headwall on WS toe.

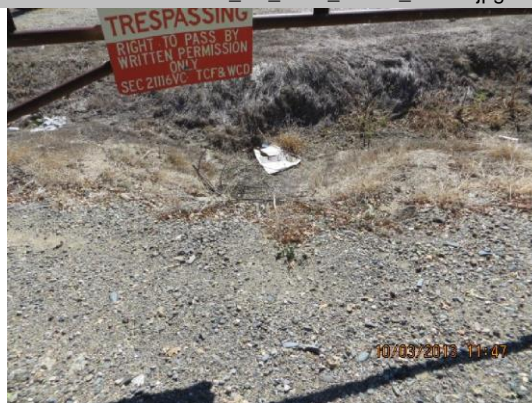
Photo 2 of 2 : UCIP_FA_2016_41124_36952.jpg

Inlet at LS toe.

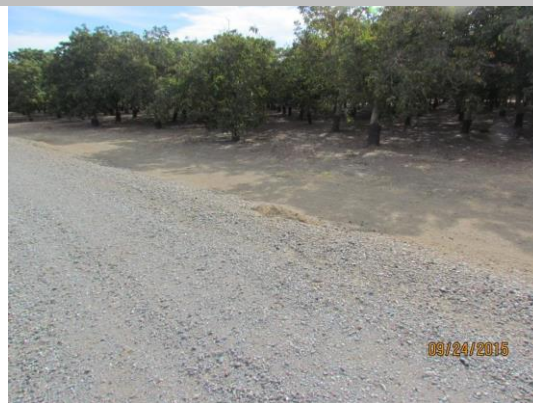
Photo 1 of 1 : FA_2016_NA0019_82_8_20160823_00003.jpg

View of the rodent holes along the landside slope.

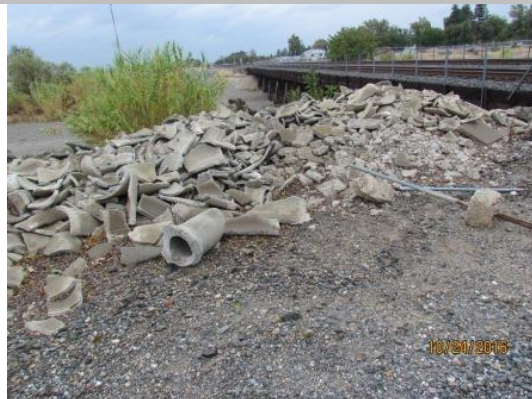
Photo 1 of 1 : FA_2016_NA0019_82_14_20161107_00016.jpg

View of the broken pipes along the waterside slope.

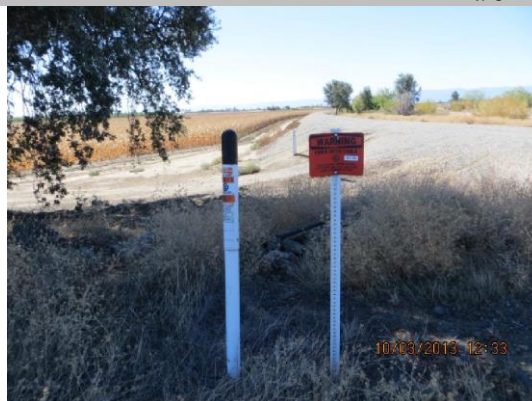
Photo 1 of 2 : UCIP_FA_2016_23052_39137.jpg

Fiber optic line markers on LS shoulder.

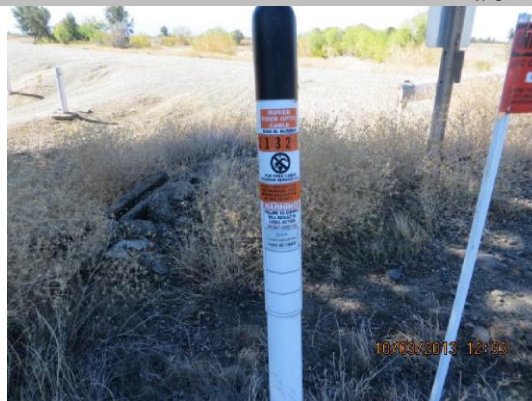
Photo 2 of 2 : UCIP_FA_2016_23052_39136.jpg

Fiber optic line markers on LS shoulder.

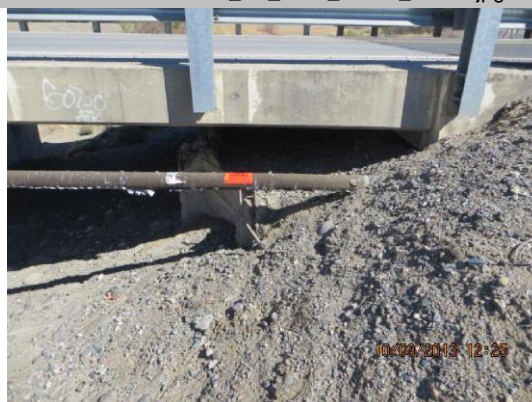
Photo 1 of 2 : UCIP_FA_2016_23044_39104.jpg

Gasline on upstream side of bridge.

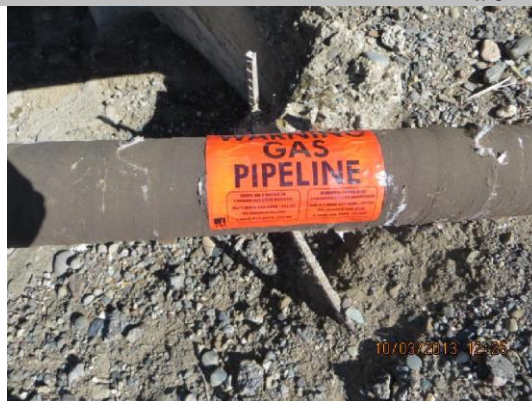
Photo 2 of 2 : UCIP_FA_2016_23044_39103.jpg

Gasline on upstream side of bridge.

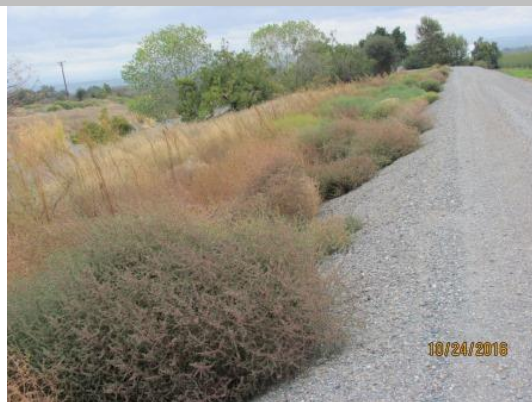
Photo 1 of 1 : FA_2016_NA0019_82_15_20161107_00017.jpg

View of the annual grass along the waterside slope.

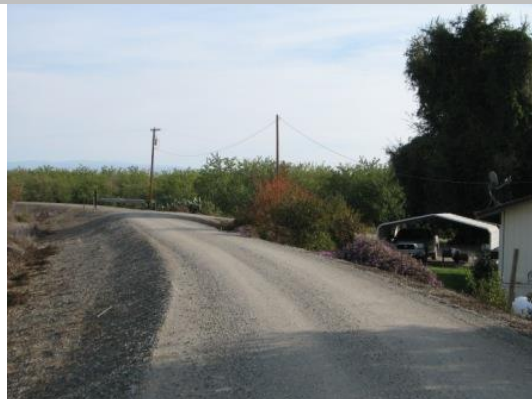
Photo 1 of 1 : FA_2016_NA0019_82_2_20160823_00001.jpg

View of the landscaping along the slope.

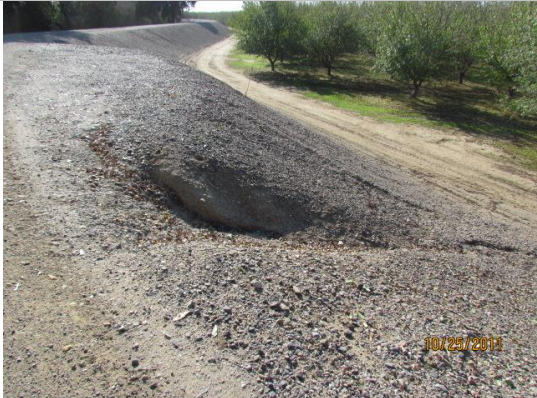
Photo 1 of 1 : FA_2016_NA0019_82_7_20160823_00002.jpg

View of the erosion along the landside slope.

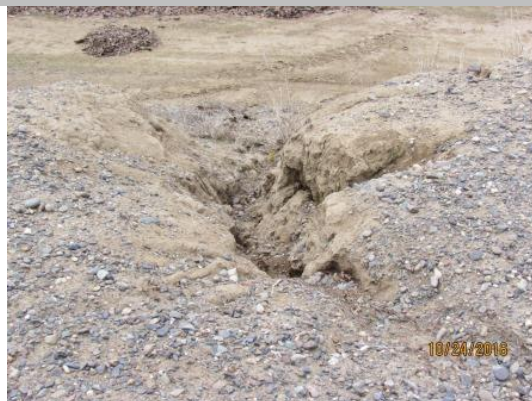
Photo 1 of 1 : FA_2016_NA0019_82_18_20161107_00019.jpg

View of the erosion along the landside slope.
